Internal Bleaching As An Esthetic Management For Discolored Non-Vital Tooth Post-Endodontic Treatment: Case Report

Objective: To present a clinical case demonstrating the application of internal bleaching using the walking bleach technique for the esthetic management of a non-vital, endodontically treated maxillary central incisor.

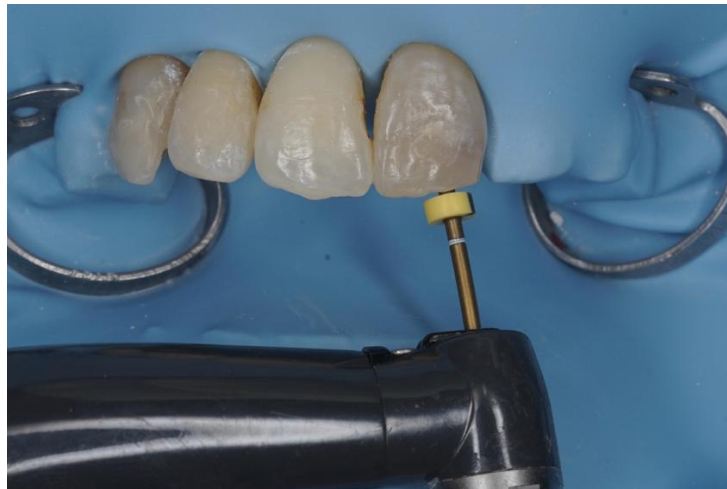
Root canal preparation with Rotary Protaper Gold (Dentsply Maillefer, Switzerland) and master apical file (MAF) F3 on tooth 21 is demonstrated in Figure 3. Irrigation with 5.25% NaOCl at each change and application and use K-File #10 to recapitulate, 17% EDTA and distilled water was performed using a 5 ml syringe with a side-vented 31G needle (Dia-dent, Netherlands). The irrigants were activated using sonic activation of irrigation materials. The canals were dried with endodontic suction and sterile paper points (Meta-Biomed, South Korea). Following canal drying, a calcium hydroxide medicament (Calcipect, Nishika, Japan) was placed into the root canals and

Figure 3. Preparation using Protaper Gold

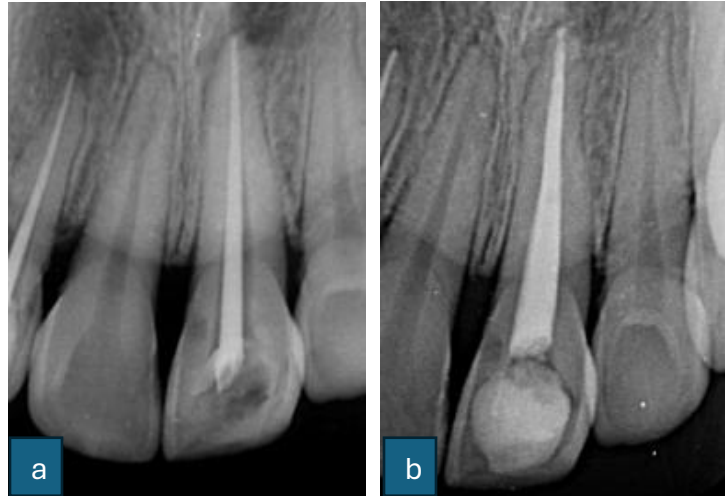
On the third visit, after two weeks. The patient reported no symptoms. Following examination, local anesthesia and rubber dam isolation was achieved. The temporary restoration and calcium hydroxide were removed. Final irrigation was performed with 5.25% NaOCl, 17% EDTA, and distilled water, followed by activation of irrigants. The canals were dried with paper points. A gutta-percha fit test (ProTaper Universal, Dentsply Sirona, Switzerland) was carried out by placing the master cones into canal up to the working length, and the fit was verified radiographically (Figure 4a). Subsequently, a single cone technique with a bioceramic sealer (Ceraseal, Meta Biomed, South Korea), extending up to 2 mm below the canal orifices. The access cavity was then sealed with a temporary restorative material. A post-obturation radiograph was obtained to confirm the adequacy and quality of the root canal filling (Figure 4b).

Figure 4 a. Gutta-percha fit test, b. Root canal filling radiography

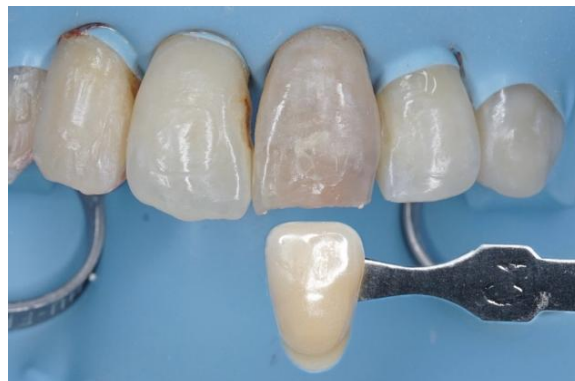
On the fourth visit, tooth shade evaluation was performed using a shade guide at the patient's initial presentation. The tooth initial shade was determined using the Vitapan Classical shade guide, recorded as C4 (Figure 5), and an initial photograph was taken as a baseline reference for evaluating the success of bleaching treatment. Comprehensive extraoral and intraoral examinations were performed, revealing no abnormalities. Percussion and bite test were negative, and the temporary fillings were in good condition with healthy surrounding gingival tissues. Following rubber dam isolation, the temporary restoration was removed, and gutta-percha was retrieved to a depth of 2 mm below the cemento-enamel junction (CEJ) using a heated plugger with stopper. The depth was confirmed with a periodontal probe (Figure 6) and radiographic verification. The cavity was then irrigated with sterile distilled water, dried, and a 2 mm glass ionomer cement (GIC) barrier was placed with a ski slope formation from the proximal side and a bobsled tunnel from the labial side until the radiographic confirmation.

Figure 5. Initial shade guide measurement (C4)

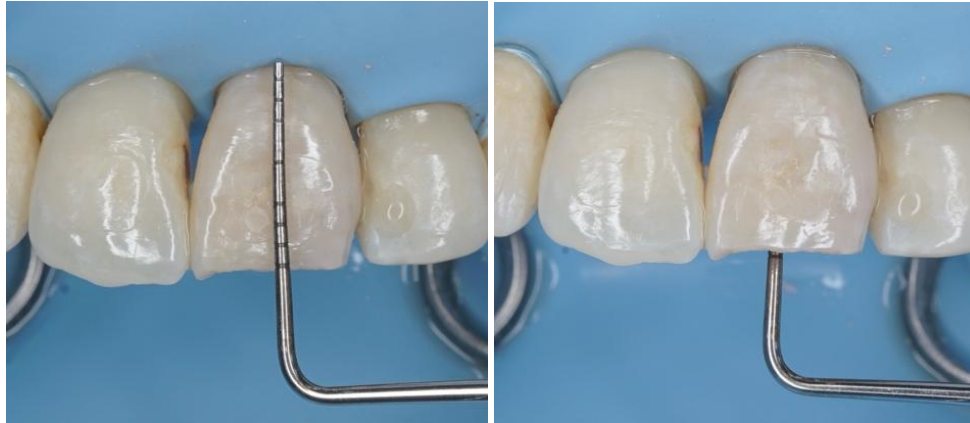
Figure 6. Determining and measuring the depth of the barrier on the labial

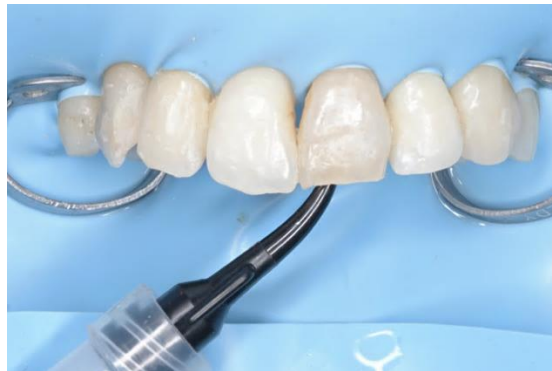
After cervical seal dried, internal bleaching was performed by applying 35% hydrogen peroxide (Opalescence Endo, Ultradent Products Inc., South Jordan, UT, USA) into the pulp chamber (Figure 7), which was then covered with a cotton pellet and sealed temporary with GIC. The patient was advised to monitor color changes daily and radiographs were taken to confirm the adequacy of the root canal barrier is shown in Figure 7. The patient was instructed to control 1 week later.

Figure 7. Bleaching material application

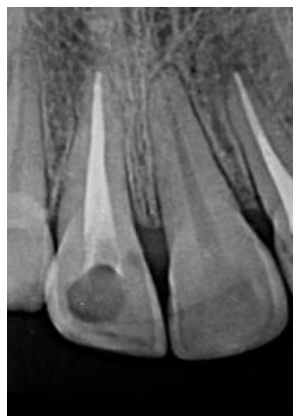
Figure 8. Root canal GIC Barrier radiograph

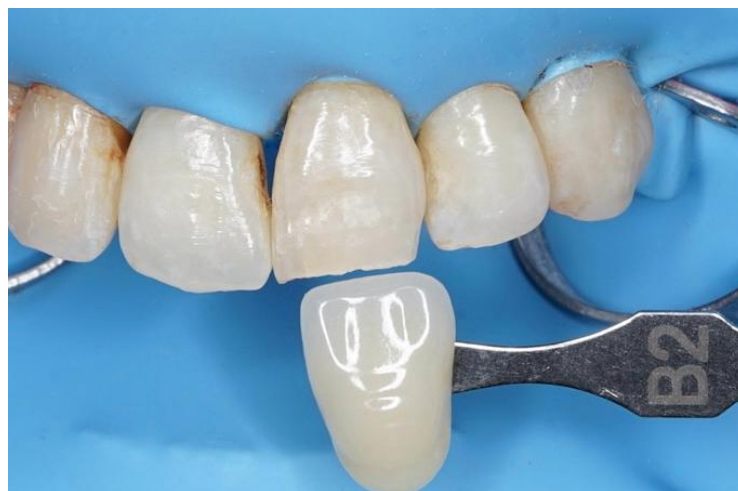
On the sixth visit, after one week. Extraoral and intraoral examination were unremarkable with negative percussion and bite test responses, and the condition of the filling was good and the surrounding gingiva was normal. Objective examination showed that tooth discoloration from C4 to B2 (Vitapan Classical) (Figure 9), which matched the patient's preference and was harmonious with adjacent teeth. After rubber dam placement, the GIC filling was removed, and the cavity was irrigated to eliminate residual bleaching agent before drying. The pulp chamber was rinsed, dried, and calcium hydroxide was placed for 1 week before the placement of the permanent restoration, and temporarily sealed.

Figure 9. At the sixth visit, the tooth shade changed from C4 to B2

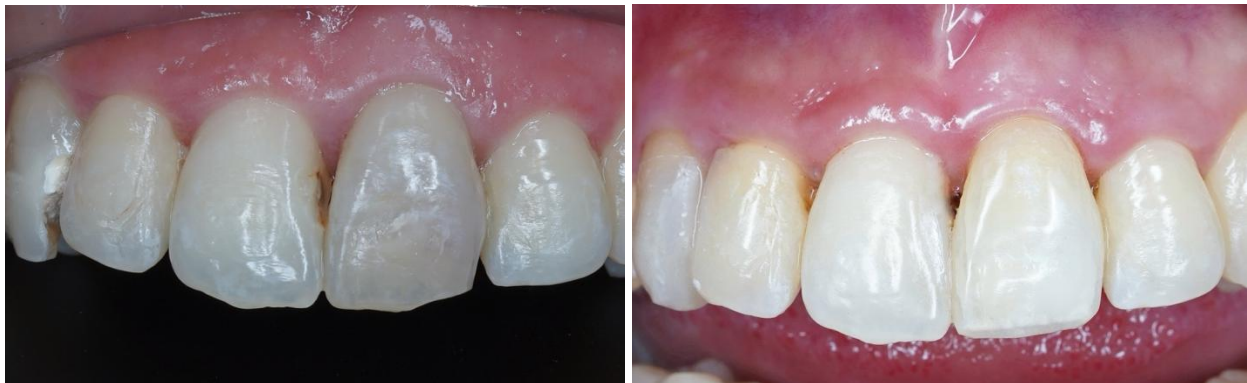
During eighth visit, extraoral and intraoral examinations were unremarkable. The restoration remained in good condition with stable tooth color and excellent marginal adaptation. Clinical assessment was performed by comparing the post-treatment tooth shade with its original one before treatment using Vita shade guide and photographs. Before and after treatment clinical photographs are shown in Figure 11.

Figure 11. Before and after treatment
